Long-Term Testing Condor SS

Soil Sample: Tulsa, OK Midtown Area

Tests Performed: Soil expansion and contraction with moisture changes using an expansion index consolidometer, 2.44-inch diameter soil sample, 60-p.s.f. loading

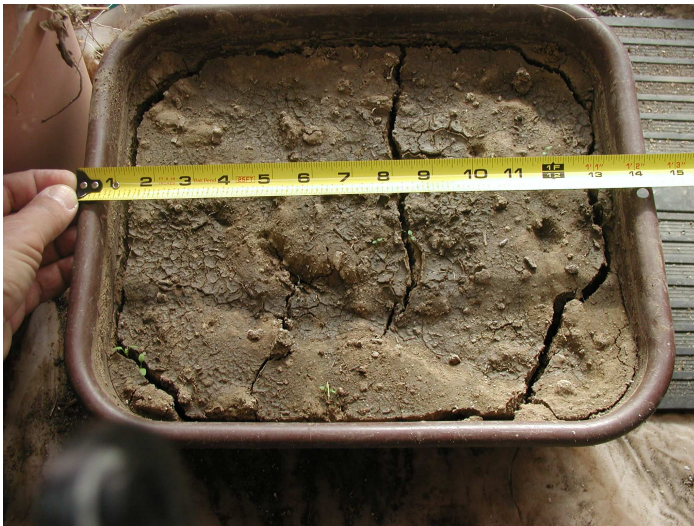
The following paragraphs show the results of long term testing of Condor SS in a soil sample that had a large amount of clay and that had historically caused seasonal wet/dry movement of a residential foundation. The photo to the left shows the magnitude of cracking of the soil that would typically be expected during a wet/dry cycle. Many of the cracks over this sample were almost $\frac{1}{4}$ inch. The total aggregate cracking over the 14-inch pan was estimated at almost 0.5 inches. Thus one would expect a wet/dry change in expansion from dry to wet of about $0.5/14 = 3.57\%$. The home at the location where this soil sample was taken had experienced horizontal (lateral) expansion and contraction of at least 0.5 inches over a span of exterior wall approximately 30

feet. The home was constructed on a layer of clay over sandstone. The amount of clay varied over a depth of 3-8 feet below the surface. The soils in this area historically show plastic indices over 20 and over 50% of clay.

The first three wet/dry cycles in Test 1 used only standard tap water for wetting the soil. It will be noticed that the first expansion cycle showed a vertical expansion (PVR) of 3.5%. This is very close to the estimate of expansion derived from the visual tub test in the first photo in this paper. Subsequent wet/dry cycles produced between 1.8-2% of vertical expansion.

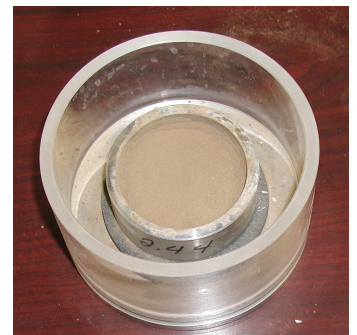
The photo to the right shows the clay soil sample within the consolidometer, dry compacted prior to testing. The test was designed to find the maximum expansion that could be expected from the totally dry state. This deviates from some standard tests methods because many times the standard tests first add water to make sure the clay is in the range of optimal moisture content. Standard testing then can underestimate the amount of expansion of clay soils when the soil is very dry, foundation construction proceeds, and then the soil absorbs moisture during rain cycles. This situation will regularly occur during summer months of

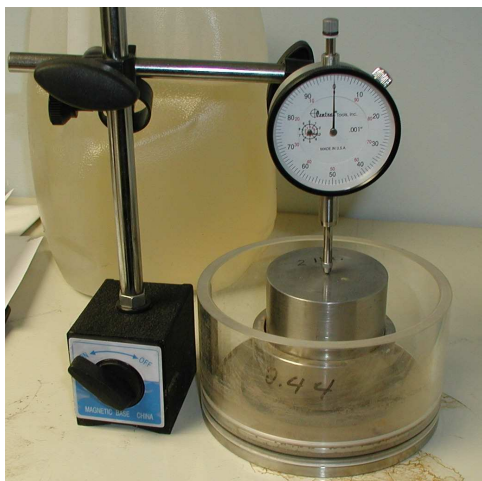
The next photo to the left shows the same soil sample with the 60 p.s.f. loading weight and differential gage used to measure the expansion characteristics of the soil. The soil is in a dry state just

prior to adding water.

Water was added to the soil sample allowing the water to be absorbed from the bottom up through the porous bottom stone. This simulates the normal absorption characteristics of the clay soil.

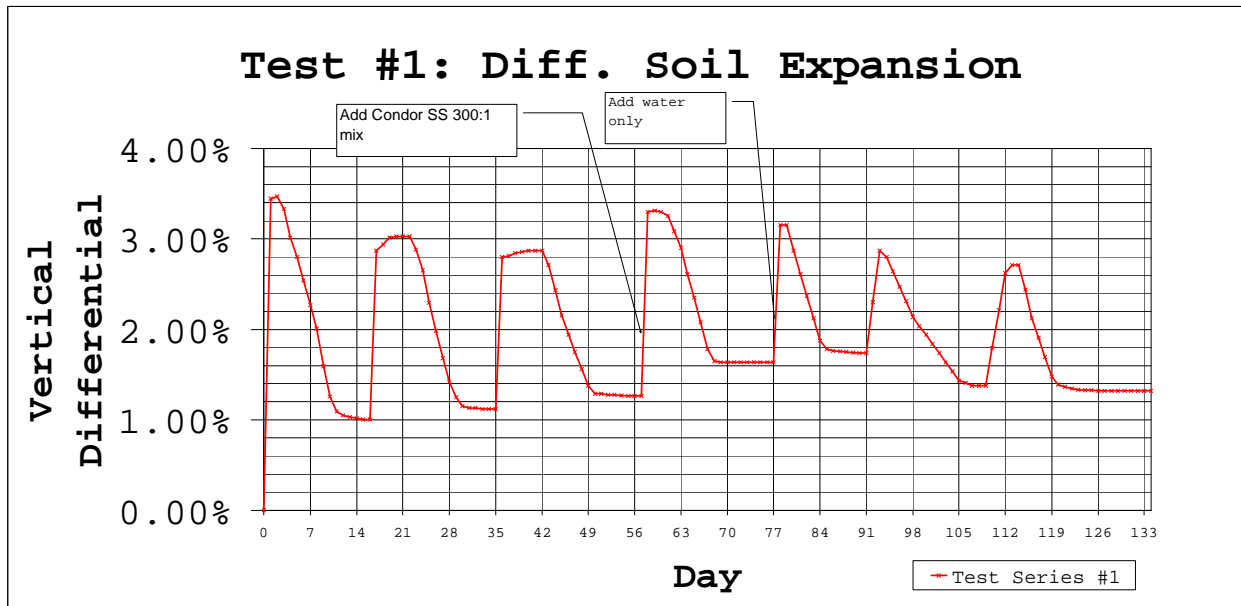
After water was added and the initial expansion of the soil was measured, the soil sample was allowed to air dry with out disturbing the test apparatus. Normally it would take approximately one to two weeks for the sample to reach its driest (minimum expansion) state. This procedure was duplicated over several wet/dry cycles. The expansion and contraction during several of these cycles is depicted in the graph below "Test 1".

At day 57, a 300:1 mixture of Condor SS was added in lieu of plain tap water. It will be noted that the first day that it was added the PVR was about 2.2%. There is no ready answer why a PVR of 1.6-1.8% did not result, other than the higher degree of absorptivity of the Condor SS mixture. During the last cycle shown in the above graph, the PVR was dropping to 1.3% but this was not considered dramatic enough of a reduction. It was thought that there was insufficient ionic bonding taking place, so a second treatment was made thus boosting the total Condor SS applied to the equivalent of a 150:1 mixture. The results appear in the next chart.

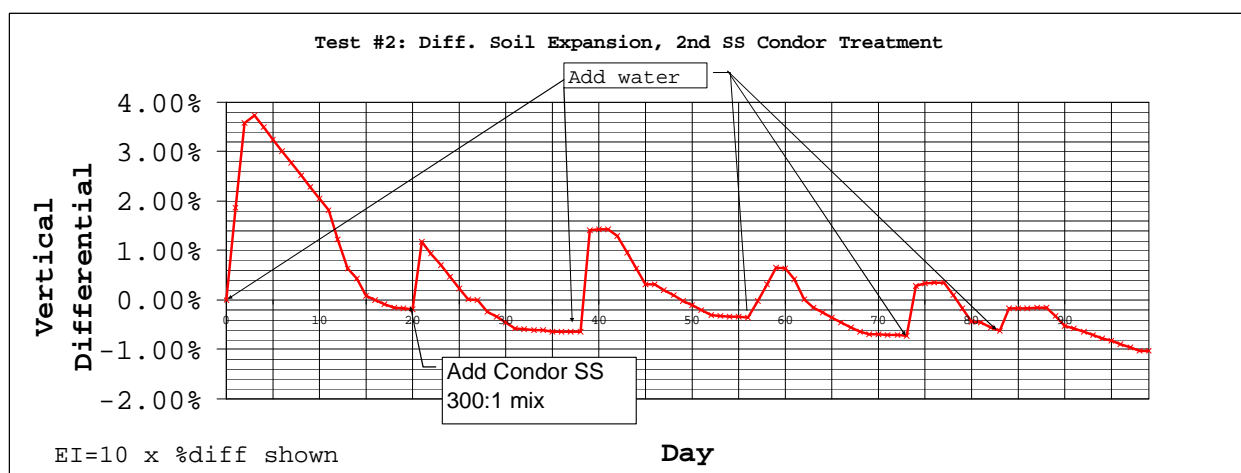
To re-establish a baseline, only pure water was again added for the first expansion cycle of the above plot. At the point noted, the soil sample was treated again with a 300:1 mixture of Condor SS. At the end of this second 2.5-month test, one will now note that the PVR has dropped to approximately 0.4% during the last cycle. **This is a dramatic improvement!** It will also be noticed from this plot that the last few cycles appear to have gone negative. This should be ignored because the differential gage was reset to zero at the start of the second test.

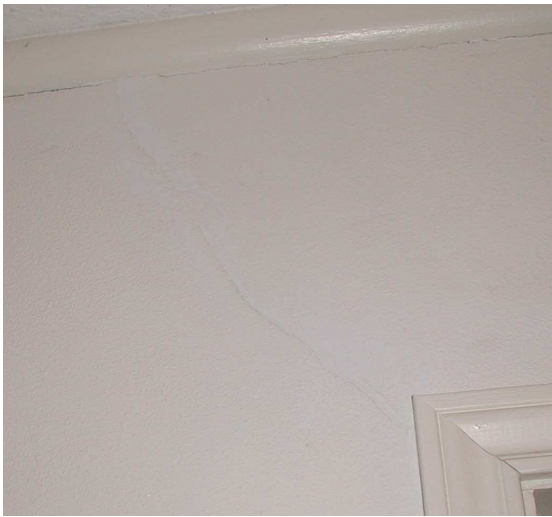
Photo 1: $\frac{1}{4}$ " crack running diagonally from an interior door up to the ceiling.

After this series of lab tests, it was decided to treat the actual home where these soil samples were taken. Only the outside perimeter of the home was treated to a depth of 5-feet, injections 3-feet on centers, with a 300:1 solution of Condor SS. After 6 months, two open sheetrock cracks $\frac{1}{4}$ "- $\frac{3}{8}$ " in width were filled with standard sheetrock compound. See the next series of photos documents the status of the filled cracks almost 5-6 months after filling. **Even after two years of wet/dry cycles the sheetrock compound used to fill the cracks did not show even hairline cracks that would indicate further movement of the sheetrock.**

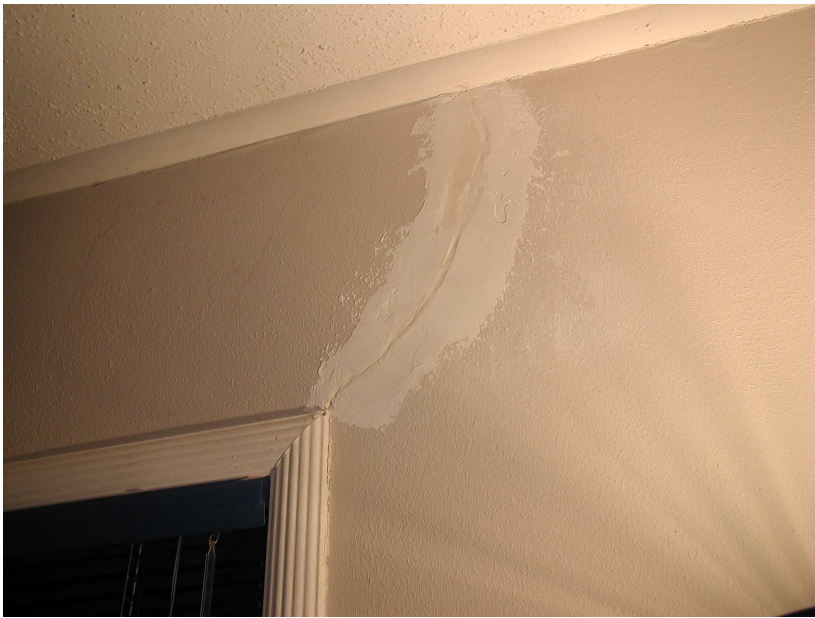
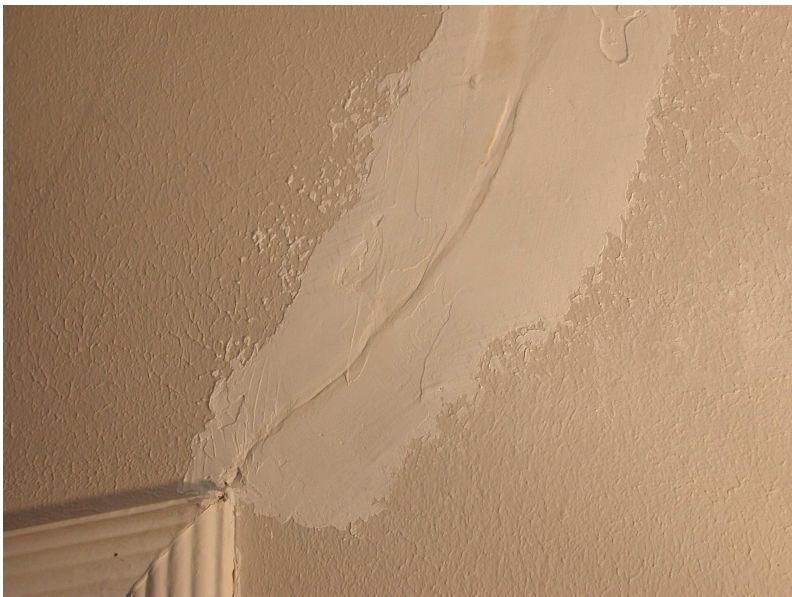
Photos 2 and 3: 1/2" crack that opened and closed. Crack had been filled with compound for over two years and was left unfinished and not smoothed out. Nevertheless, cracks have never appeared within the filled opening.

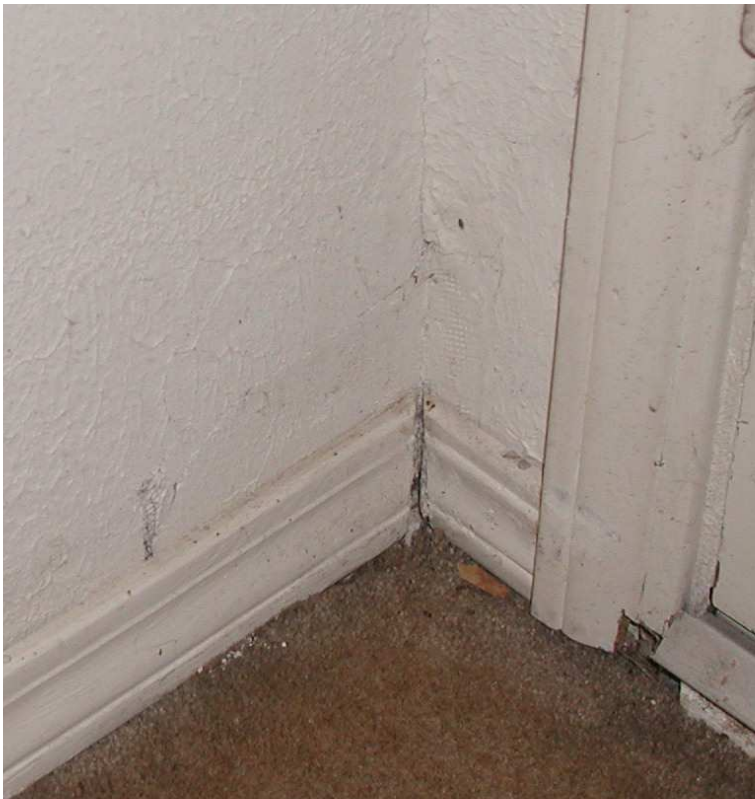
Photo 4: Separation of baseboard molding near an exterior door showing a crack. This crack was never repaired and the photo is depicted only to show the amount of movement along this long interior wall.
